# Manhole Inspection Summary

Manhole # S190\_\_010MH

Insp Date: **3/19/08 1:06 PM**

**Location** Address: **2201 eagle st**

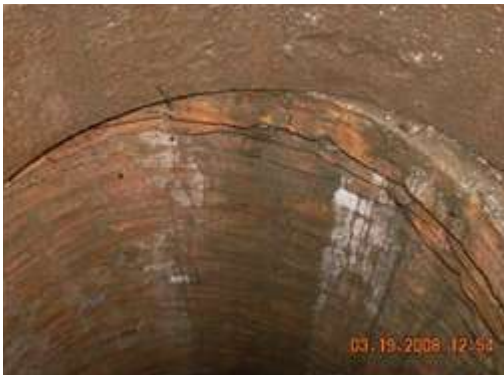
Defect 2

Infiltration: ☐ None ☒ **Joint** ☐ Cracks ☐ Mortar ☐ Roots ☐ Wall

infiltration @ chimney joint

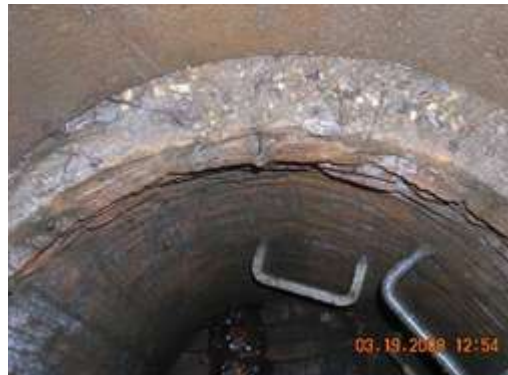
Defect 1

Offset: **4** (in.)

frame offset

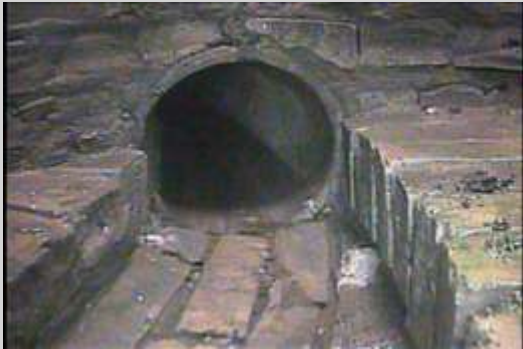
12 O'Clock Outflow

Pipe Height: **8.4** (in.) Rod and Bar (Angled)  
Pipe Material: **Clay** ☐ Pipe Lined  
Invert Depth: **7.48** (ft.) Flow Characteristics: **Slow**  
Deposits: ☒ None ☐ Mud ☐ Sludge ☐ Debris ☐ Grease  
Silt Depth: **0** (in.) Deposits Extent:  
Infiltration: **None** Pipe Seal Cond: **Cracked**

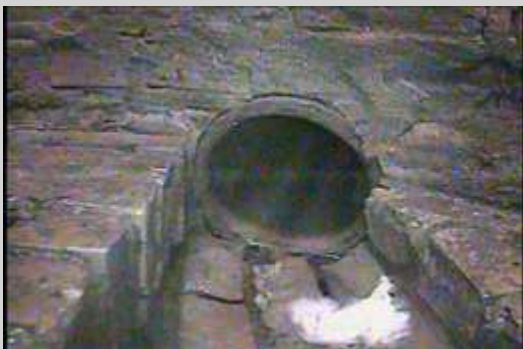
7 O'Clock Inflow

Pipe Height: **6** (in.) Rod and Bar (Angled)  
Pipe Material: **Clay** ☐ Pipe Lined  
Invert Depth: **7.39** (ft.) Flow Characteristics: **Slow**  
Deposits: ☒ None ☐ Mud ☐ Sludge ☐ Debris ☐ Grease  
Silt Depth: **0** (in.) Deposits Extent:  
Infiltration: **None** Pipe Seal Cond: **Sound**
